Caldwell First Nation Flood Risk Identification

September 23, 2020

RiverLabs – A Division of the St. Lawrence River Institute

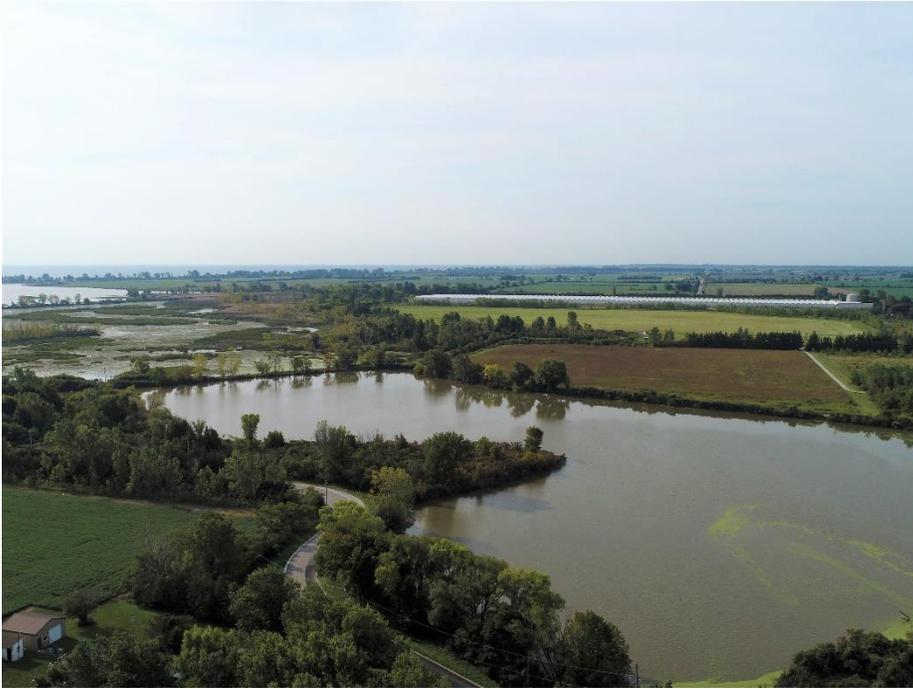
Figure 1. Aerial view of Hillman Marsh and surrounding lands, which include several Caldwell First Nation properties.

level for Lake Erie. As a result of this topography, the Point Pelee region was historically a large wetland complex, with periods of frequent inundation from Lake Erie. Although altered, representation of the historic landscape conditions is maintained in the Point Pelee National Park and Hillman Marsh areas of the point which support wetland habitat for a range of aquatic fauna and flora (Figure 1).

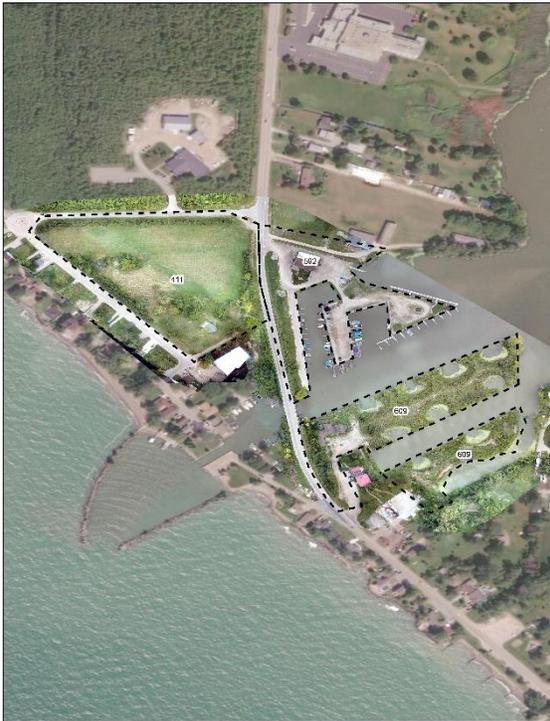
Appendix B – Marina Complex

Property Complex Name:	Marina Complex	
Property(ies) Street Address:	411 Robinson Road 609 County Road 33 592 County Road 33	
Total Complex Area:	7.7 ha	
Minimum Elevation:	174.04 m	
Maximum Elevation:	179.20 m	
Mean Elevation:	175.11 m	
Total Flood Risk	Very High	0.5 ha
	High	0.1 ha
	Moderate	6.3 ha
	Low	0.9 ha

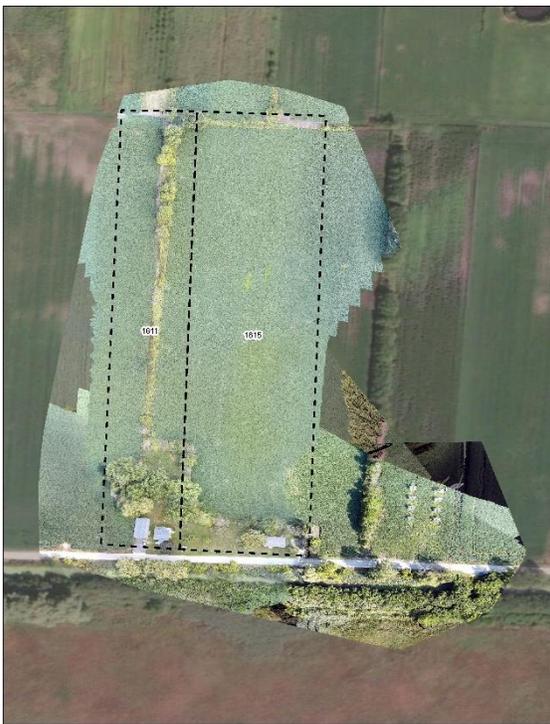
Appendix C – 1611-1615 Complex

Property Complex Name:	1611 - 1615 Complex	
Property(ies) Street Address:	1611 Mersea Road E 1615 Mersea Road E	
Total Complex Area:	4.0 ha	
Minimum Elevation:	171.75 m	
Maximum Elevation:	173.23 m	
Mean Elevation:	172.01 m	
Total Flood Risk	Very High	4.0 ha
	High	0.0 ha
	Moderate	0.0 ha
	Low	0.0 ha

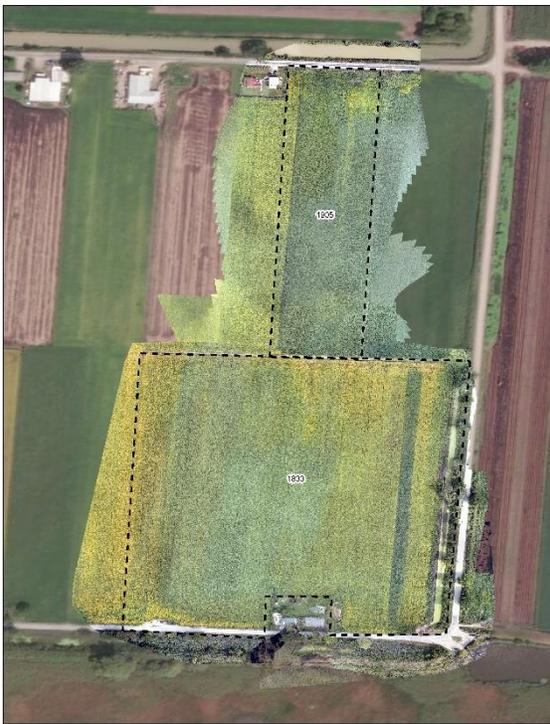
Appendix D – 1833-1905 Complex

Property Complex Name:	1833 - 1905 Complex	
Property(ies) Street Address:	1833 Mersea Road E 1905 Mersea Road D	
Total Complex Area:	12.5 ha	
Minimum Elevation:	170.47 m	
Maximum Elevation:	173.95 m	
Mean Elevation:	171.23 m	
Total Flood Risk	Very High	12.5 ha
	High	0.0 ha
	Moderate	0.0 ha
	Low	0.0 ha

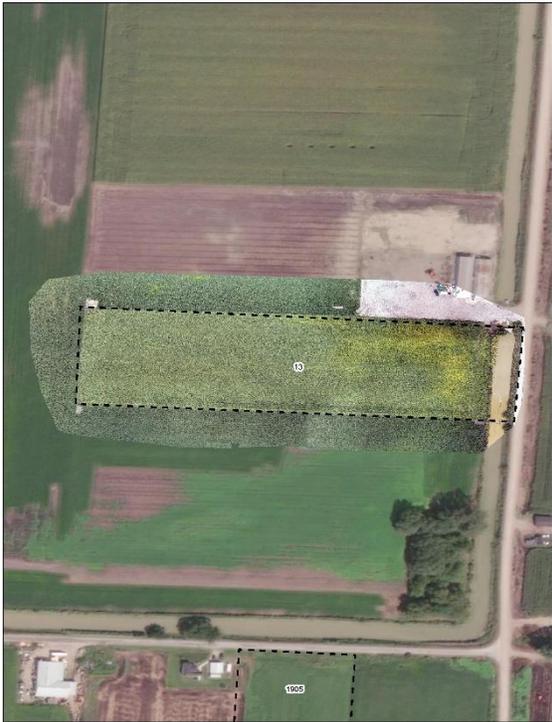
Appendix E – 13 Complex

Property Complex Name:	13 Complex	
Property(ies) Street Address:	13 Mersea Road 19	
Total Complex Area:	2.9 ha	
Minimum Elevation:	170.80 m	
Maximum Elevation:	174.20 m	
Mean Elevation:	171.87 m	
Total Flood Risk	Very High	2.9 ha
	High	0.0 ha
	Moderate	0.0 ha
	Low	0.0 ha

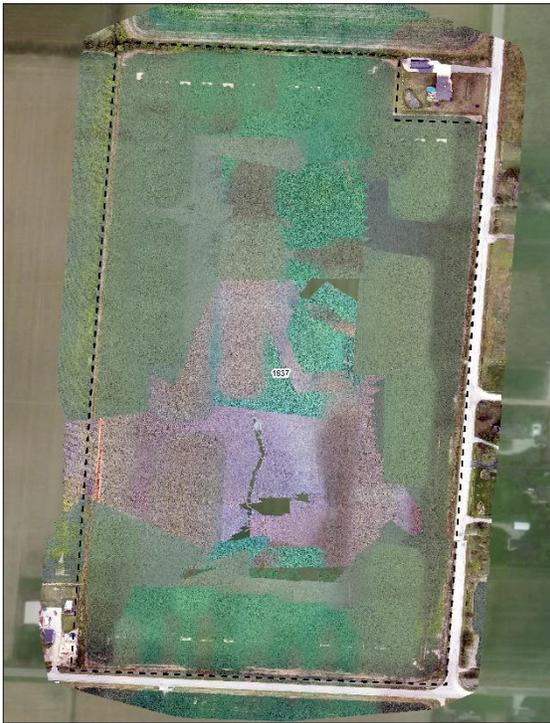
Appendix I – 1837 Complex

Property Complex Name:	1837 Complex	
Property(ies) Street Address:	1837 Mersea Road 1	
Total Complex Area:	21.9 ha	
Minimum Elevation:	174.14 m	
Maximum Elevation:	176.30 m	
Mean Elevation:	175.32 m	
Total Flood Risk	Very High	1.0 ha
	High	0.2 ha
	Moderate	16.2 ha
	Low	0.0 ha

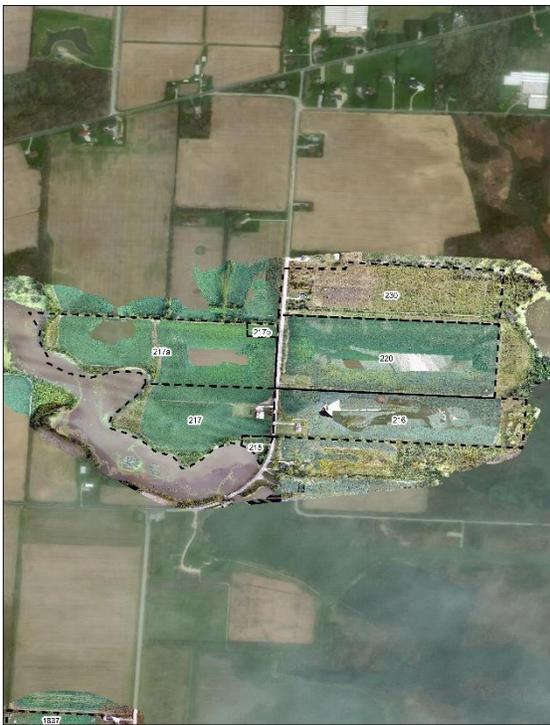
Appendix J – 215-230 Complex

Property Complex Name:	215 – 230 Complex	
Property(ies) Street Address:	215 Mersea Road 19 216 Mersea Road 19 217 Mersea Road 19 217a Mersea Road 19 217b Mersea Road 19 220 Mersea Road 19 230 Mersea Road 19	
Total Complex Area:	54.7 ha	
Minimum Elevation:	174.11 m	
Maximum Elevation:	178.12 m	
Mean Elevation:	176.47 m	
Total Flood Risk	Very High	1.9 ha
	High	0.1 ha
	Moderate	5.3 ha
	Low	47.4 ha

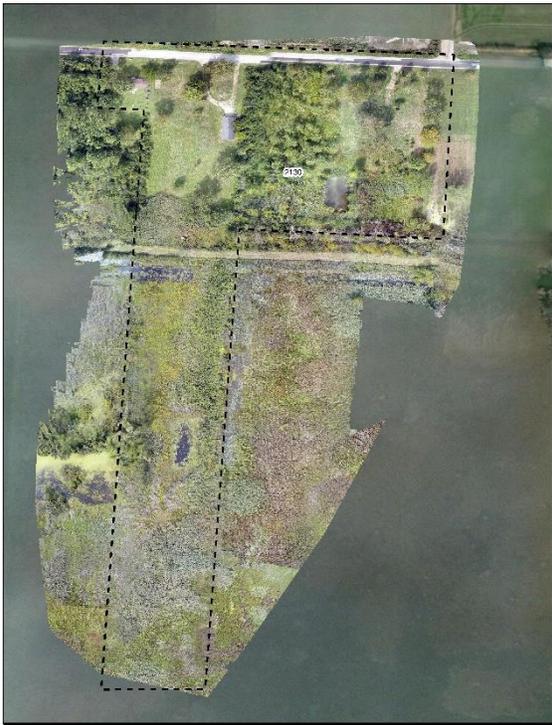
Appendix K – 2130 Complex

Property Complex Name:	2130 Complex	
Property(ies) Street Address:	2130 217 Mersea Road 2	
Total Complex Area:	5.5 ha	
Minimum Elevation:	174.26 m	
Maximum Elevation:	174.91 m	
Mean Elevation:	175.76 m	
Total Flood Risk	Very High	0.7 ha
	High	0.3 ha
	Moderate	4.4 ha
	Low	0.1 ha

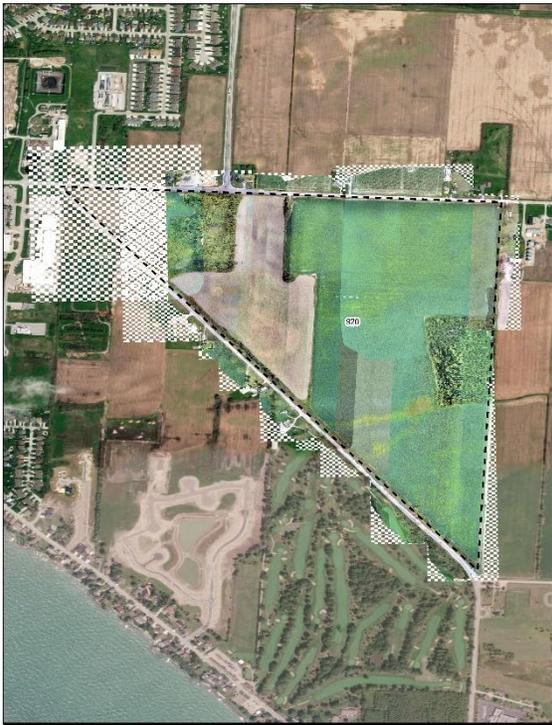
Appendix L – 920 Complex

Property Complex Name:	920 Complex	
Property(ies) Street Address:	920 Bevel Line	
Total Complex Area:	81.4 ha	
Minimum Elevation:	174.19 m	
Maximum Elevation:	182.95 m	
Mean Elevation:	176.77 m	
Total Flood Risk	Very High	5.5 ha
	High	1.1 ha
	Moderate	4.1 ha
	Low	70.7 ha

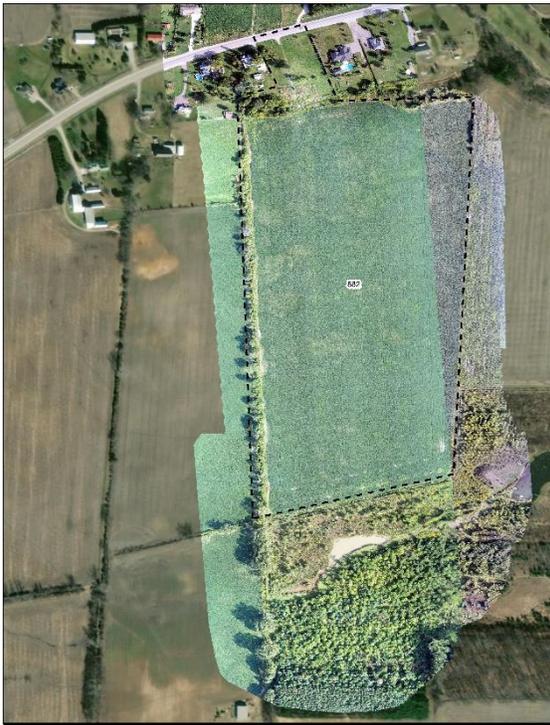
Appendix M – 882 Complex

Property Complex Name:	882 Complex	
Property(ies) Street Address:	882 Essex County Road 34	
Total Complex Area:	18.0 ha	
Minimum Elevation:	178.66 m	
Maximum Elevation:	182.26 m	
Mean Elevation:	181.27 m	
Total Flood Risk	Very High	2.2 ha
	High	0.0 ha
	Moderate	0.0 ha
	Low	15.8 ha
